Operation and Maintenance Report  
January 2019 to December 2019

## McCormick and Baxter Superfund Site

Portland, Oregon  
ECSI Site No. 74

**July 22, 2020**  
**150-002-005/Task 3**

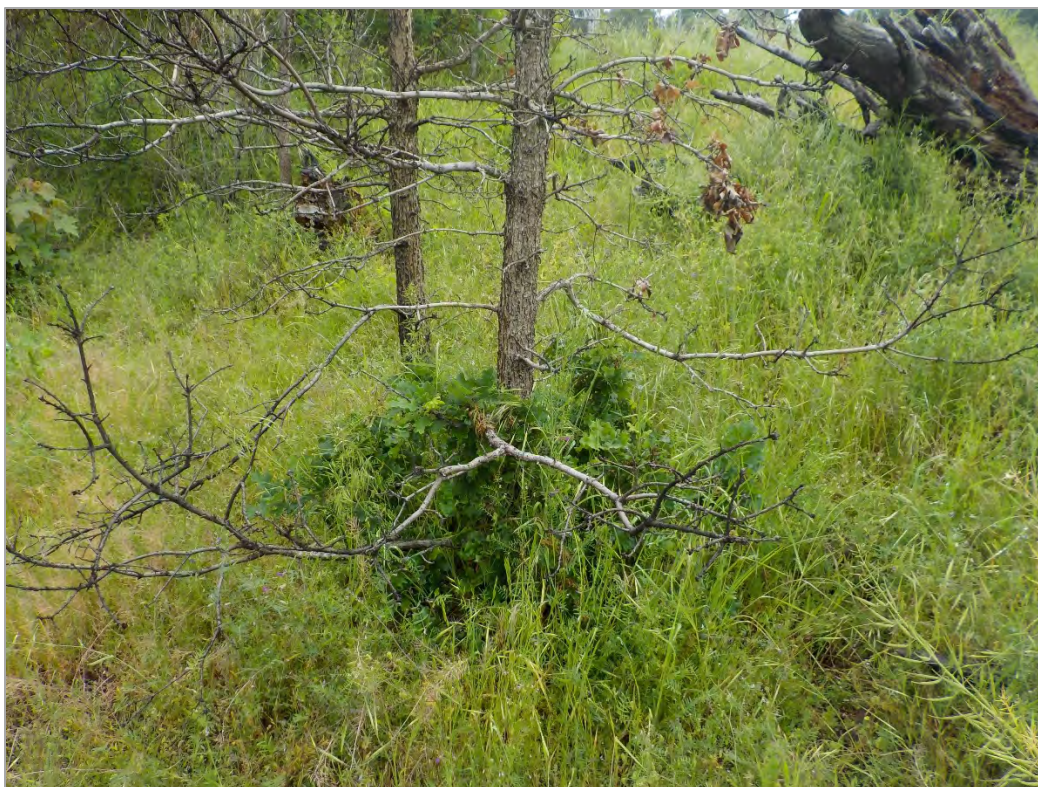
**Photograph C19:** Garry white oak suckering (regenerating) from roots (May 2019).

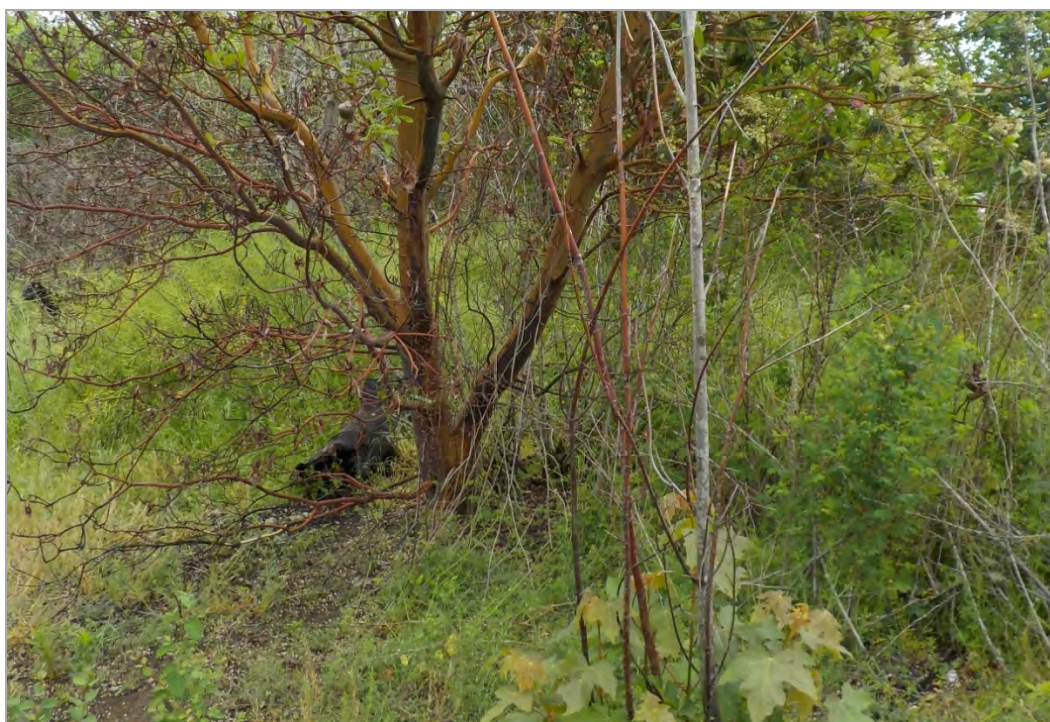
A brush fire in August 2018 burned approximately one acre in the riparian area. Groundcover in the area has recovered with grasses and some noxious weeds present. Larger trees and shrubs show signs of recovery with new leaf development. Charred limbs are still observable on brush and small trees.

**Photograph C20:** Madrone that survived burned (only lower branches died) and big-leaf maple suckering in foreground (May 2019).

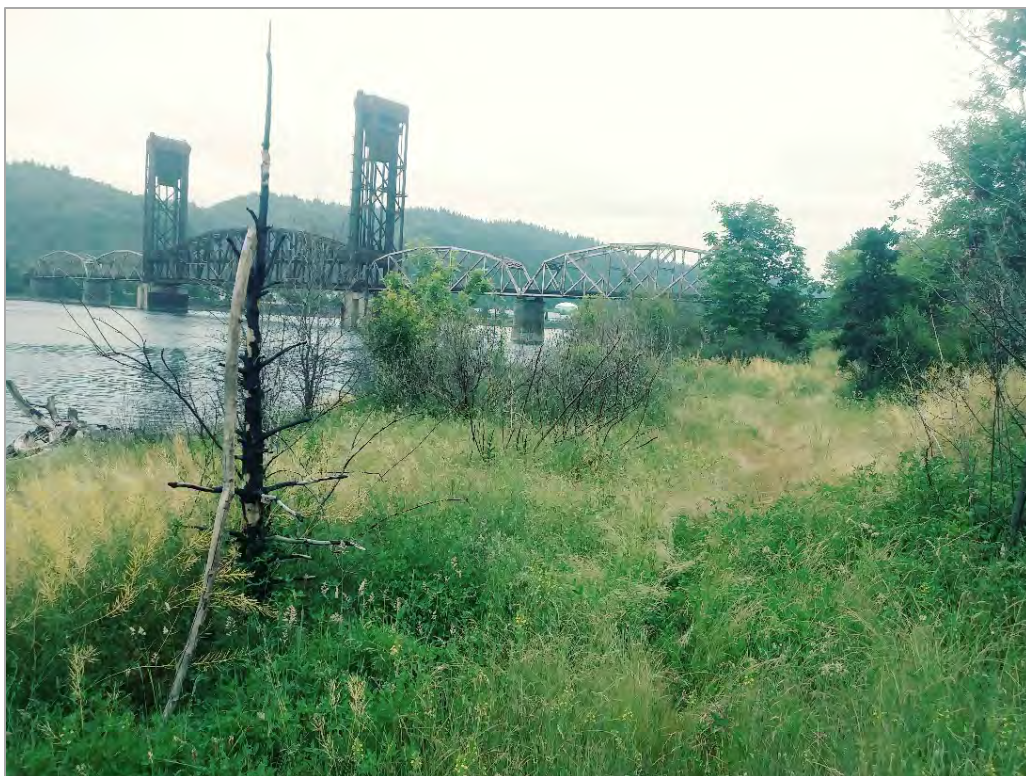
**Photograph C21:** Dead conifer along with regenerating shrubs (May 2019).

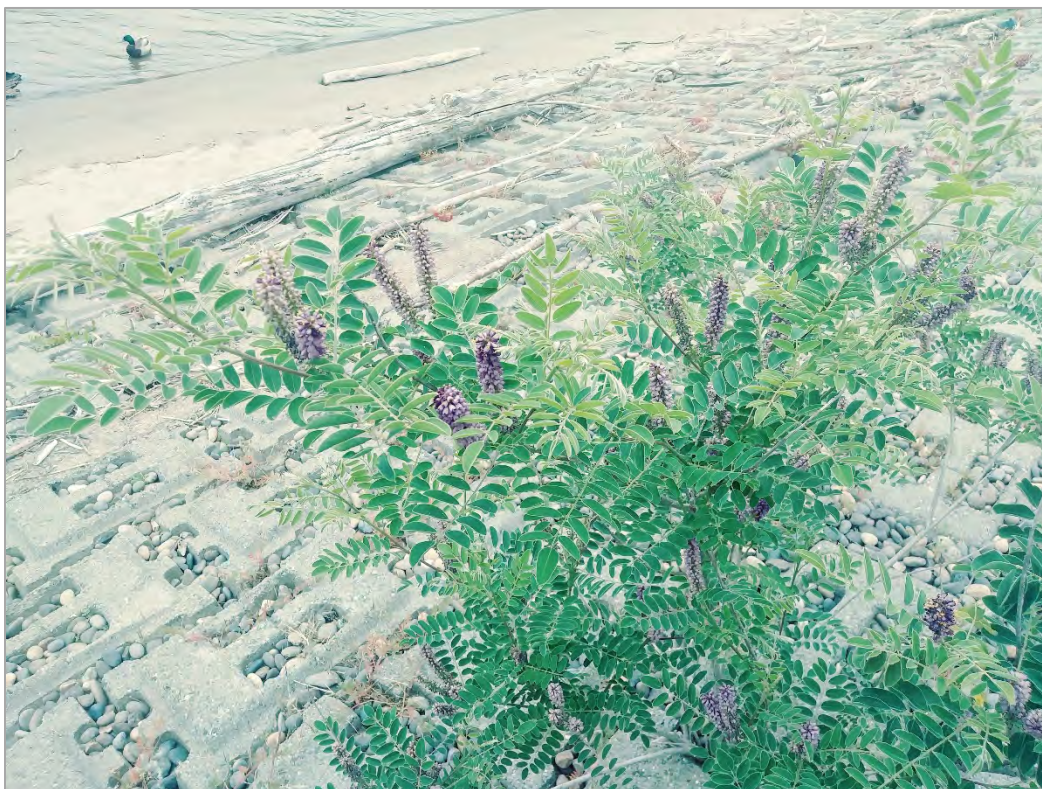
**Photograph C22:** Indigo bush (*Amorpha fruticosa*) B-list invasive (May 2019).

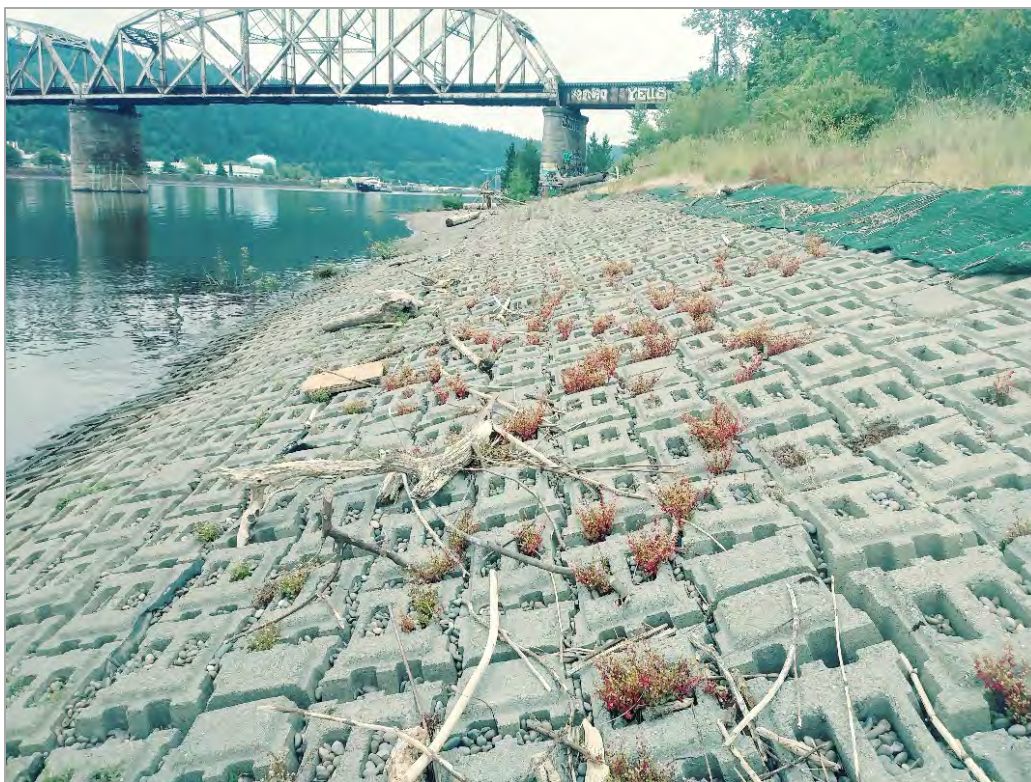
**Photograph C23:** Shiny-leaf geranium (*Geranium lucidum*) growing in lower riparian area (June 2019).

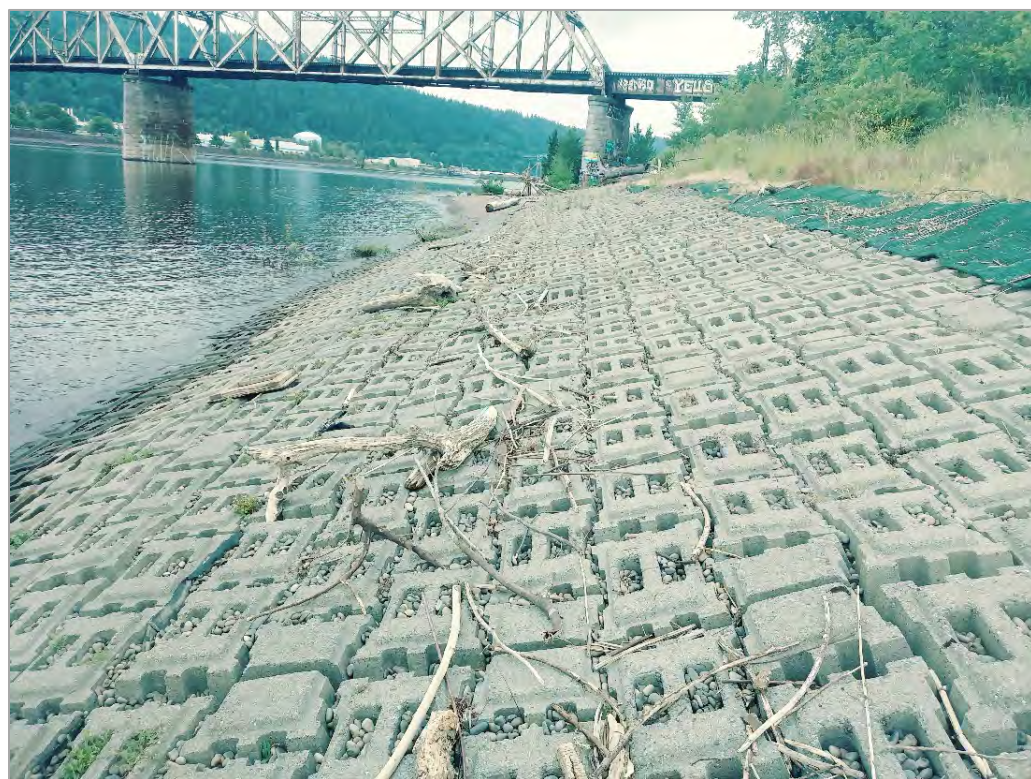
**Photograph C24:** Same area after shiny-leaf geranium removal (June 2019).

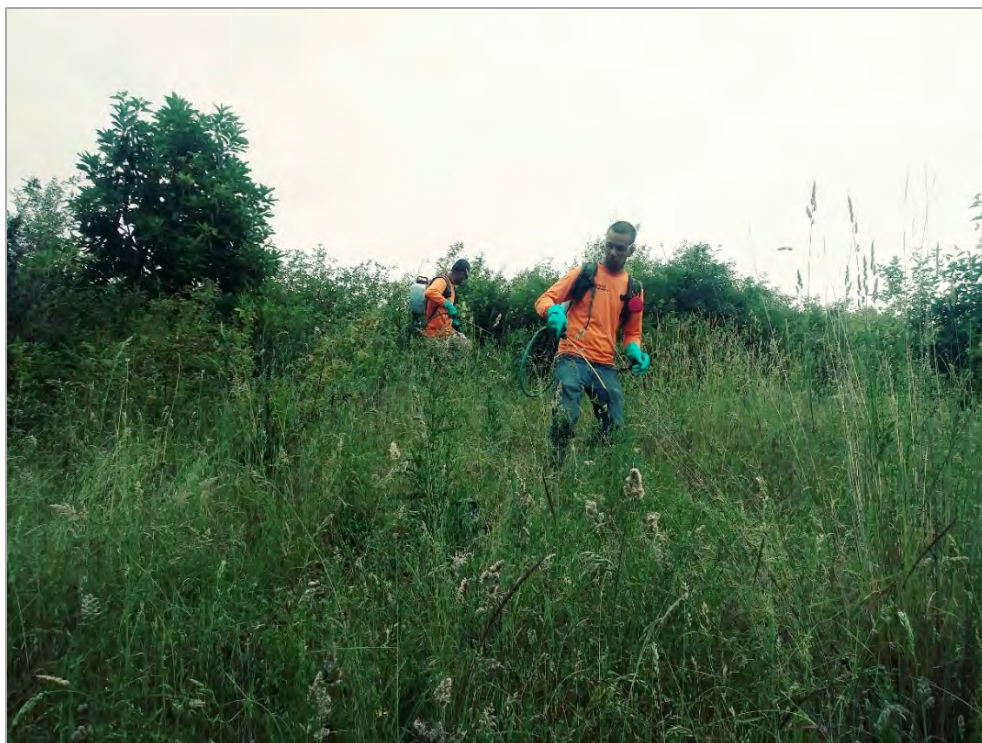
**Photograph C25:** Herbicide application (June 2019).

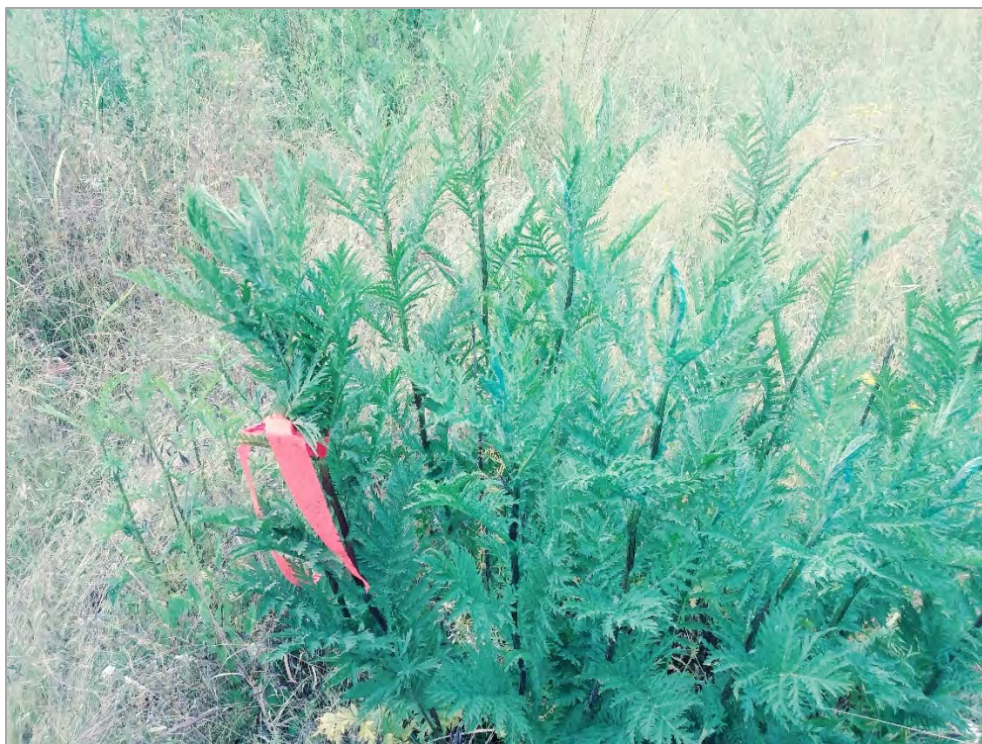
**Photograph C26:** Many plants or patches were tagged for herbicide application. Foliar spray was used for most species, including tansy (*Tanacetum vulgare*) (June 2019).

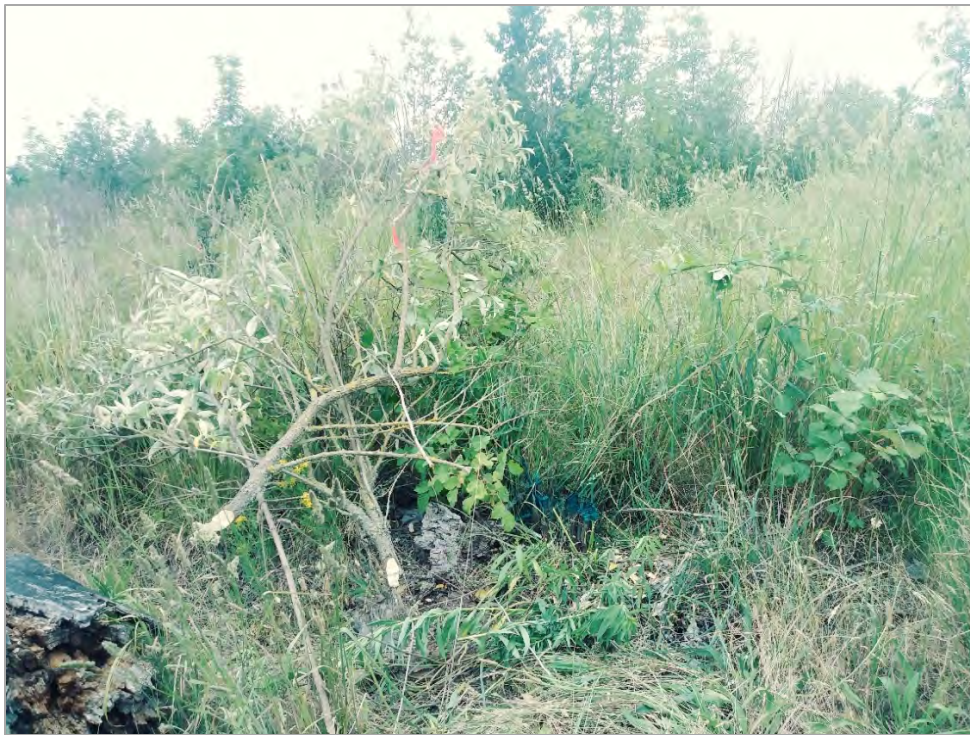
**Photograph C27:** Removal of butterflybush (*Buddleja davidii*) using cutting and stump treatment (June 2019).

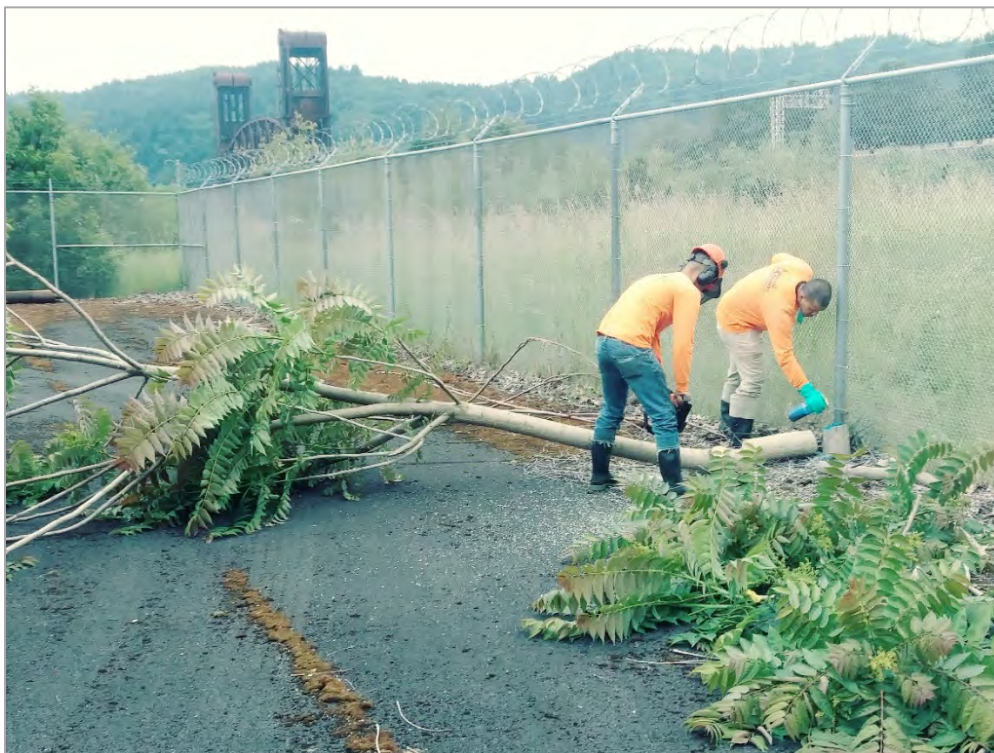
**Photograph C28:** Removal of tree of heaven (*Ailanthus altissima*) using cutting and stump treatment (June 2019).
